# STOP THE MONEY FROM GURGLING AWAY – UNDERSTANDING YOUR DRAINAGE NETWORK

Ben Symmons and Riaz UI-Islam  
Asset Management Team Leader, Opus Perth (BS)  
Senior Asset Management Engineer, Opus Sydney (R U-I)

## Abstract

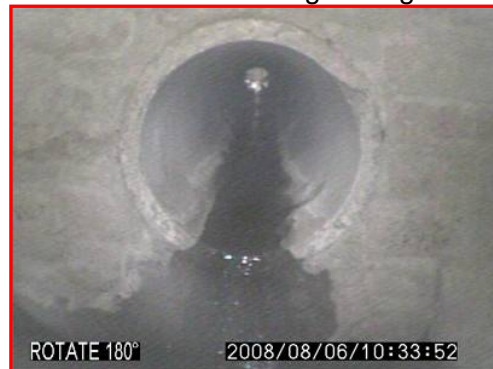
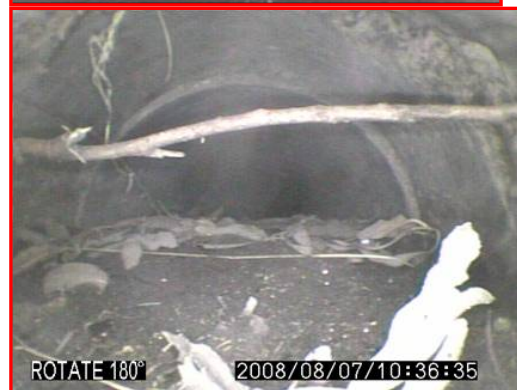
The sample photographs here illustrate the defects identified through using our methods.

Cracking inside pits was easily seen, as were blockages and pipe joint separations. The camera provided good detail for assessing the condition of assets, upon which asset management decisions may be founded. Deficiencies such as vegetation growing inside of the pit could also be easily seen and assessed. The layout and condition of drainage systems could be viewed, assessed and recorded. Field data was directly recorded in a database and could be mapped as an overlay on any geographic information system, such as Google Earth.
